Article

Non-Temporal Point Cloud Analysis for Surface Damage in Civil Structures

Mohammad Ebrahim Mohammadi ¹, Richard L. Wood ^{2,*} and Christine E. Wittich ²

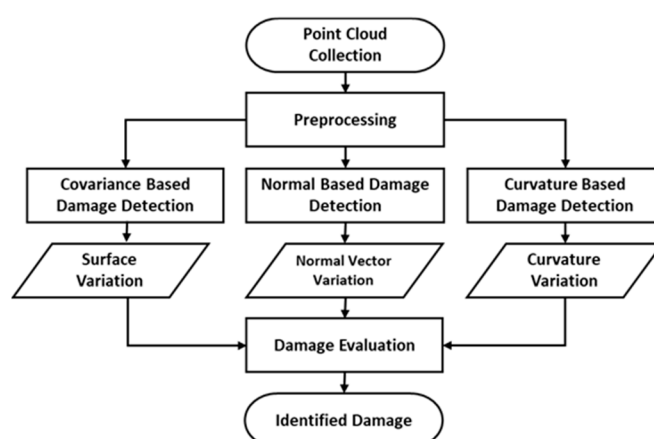
Figure 1. Synopsis flowchart of the proposed methodology.

The proposed method contains three primary vertical branches, starting with a preprocessing step and concluding with a damage evaluation step. Figure 1 illustrates the summary and an overview of the proposed method. The input to the workflow was an ASCII text file of all vertex coordinates. The workflow starts with an efficient preprocessing step that performs subsampling and outlier removal. The subsampling step reduces the vertex-to-vertex spacing (or uniform vertex density) variations to the desired value representing the desired level of damage detection. The vertex density regularization process also reduces the false positive detection results due to vertex density variation within the point cloud data. Once the subsampling process is completed, the outlier removal step eliminates the sparse

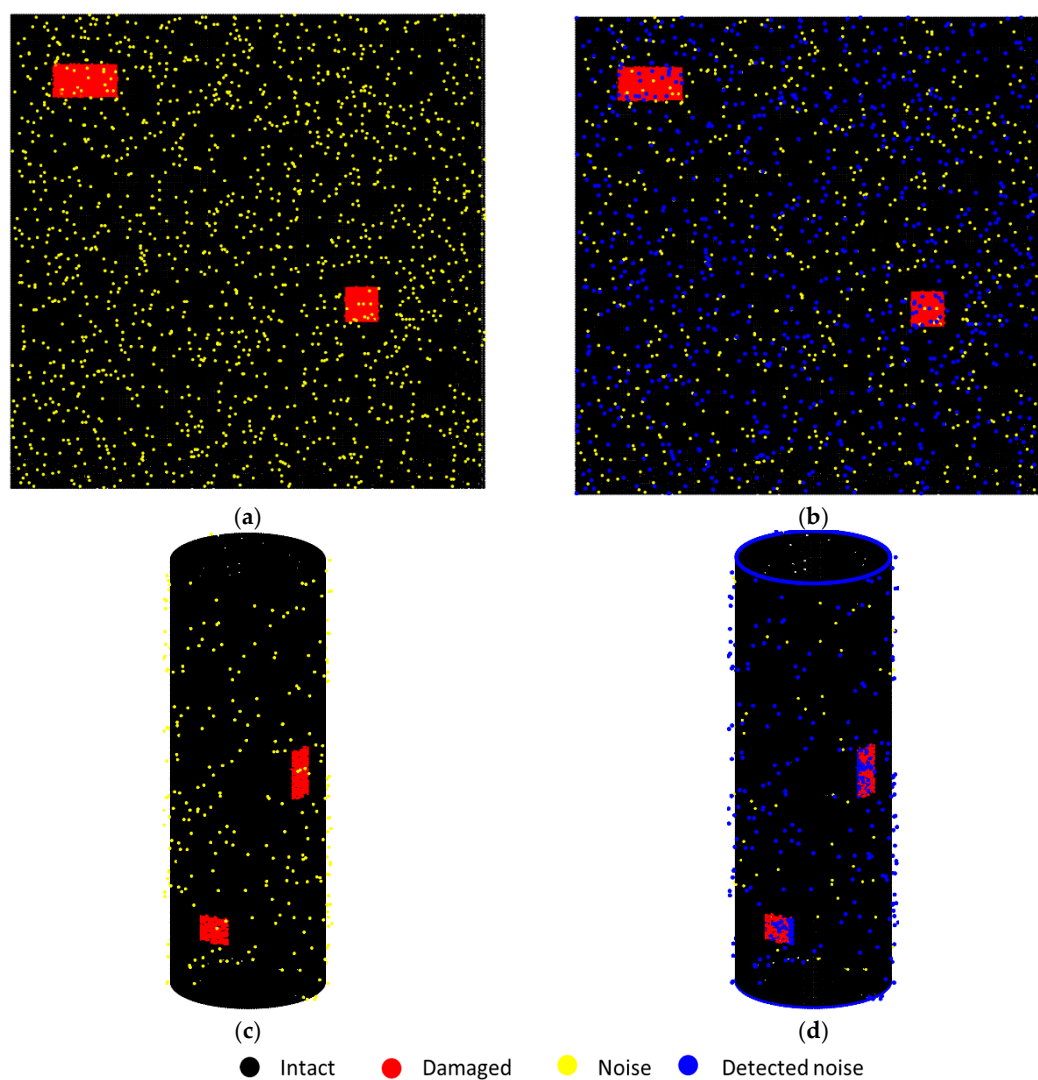
Figure 2. The performance of sparse and erroneous vertices detection method: (a) input planar point cloud (b) detected noise vertices for planar dataset, (c) input cylindrical point cloud, and (d) detected noise vertices for cylindrical datasets.

The second part of the preprocessing step was to identify and eliminate any outlying sparse vertices. These vertices may exist as a result of registration errors due to multiple lidar scan positions, noise within dense-cloud SfM reconstructions, and erroneous measurements due to free edges and reflective surfaces (e.g., laser beam scatter). Therefore, to improve detection and reduce false positives, these erroneous vertices were removed through an outlier removal procedure based on Euclidean distances of each vertex with respect to its k nearest neighboring vertices, also known as the statistical outlier removal (SOR) filter [31]. For efficiency, the k nearest neighboring vertices for each vertex were found using a kd-tree algorithm, which had a time complexity of $O(n)$ [32,33]. After identifying the k nearest neighboring vertices, the Euclidean distances of each vertex to its neighboring vertices were computed and averaged. Within this study, the k value was set to a consistent value of 31. This value was selected as the result of multiple runs on various datasets, which confirmed that the neighboring size of 31 preserves the vertices at sharp edges and boundaries while eliminating the sparse and erroneous vertices [31]. While the neighboring number of 31 was verified for the scale and density of typical civil structure geometries, a different number of neighbors could be implemented for unusual geometric objects and high-density point clouds (or very small vertex spacing). Through a computation of the mean (μ) and standard deviation (σ) of the Euclidean distances of n vertices, vertices having an average Euclidean distance greater than $\mu + \alpha \times \sigma$ will be eliminated. This implies the average Euclidean distance computed for each point is identically and independently distributed; and therefore, the distribution of average Euclidean distances of vertices is approximately normal for a large number of vertices, based on the central limit theorem. As a result, the confidence intervals for average Euclidean distances can be approximated using the normal distribution [34]. The value of the α , or the Z score, can be adjusted based on the point cloud's noise level and density. In this study, α was set to 3, which corresponds to a 99.87% confidence interval for a single-tailed Gaussian distribution. Figure 2 shows the performance of the outlier removal step, where the detected noise vertices are colored blue for both synthetic datasets. Figure 3 provides a detailed view of the simulated damaged areas. As demonstrated, the outlier removal process was able to detect and eliminate a large part of the noise vertices. However, a total of 34.4% and 26.1% of the noise vertices remained within the planar and cylindrical datasets, respectively, as would be expected for many real-world point clouds. The proposed workflow evaluates surface features of the remaining vertices and combines them in such a way that reduces the impact of this remaining noise, as discussed in the following sections.

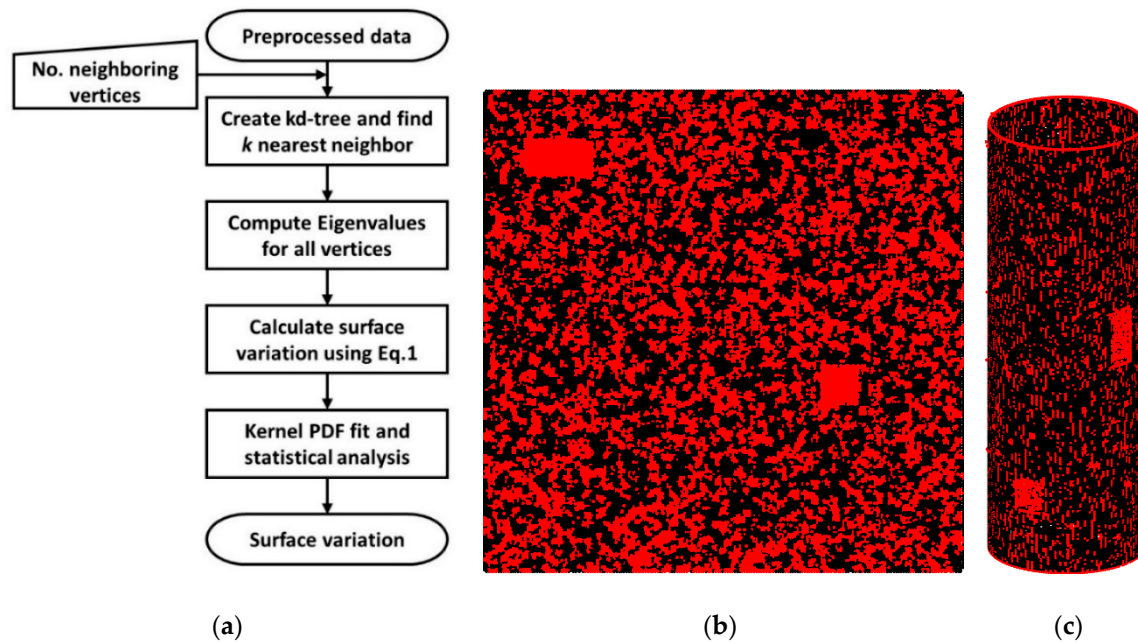
Figure 4. Likely damage by the surface variation method: (a) flowchart for the surface variation-based damage detection and detected damage areas for (b) planar and (c) cylindrical datasets where detected surface anomalies are shown in red color (or gray color in black and white versions).

Results of the SV classification are shown in Figures 4 and 5. Figure 5 illustrates the log-log plot of the Kernel probability distribution of the SV values along with the highlighted inflection point for both synthetic datasets, which corresponds to a confidence level of 53.5% and 76.7% for planar and cylindrical datasets, respectively. As demonstrated, most of the computed surface descriptor values have a value close to zero (i.e., undamaged). Therefore, the algorithm selects the inflection point to the right of the PDF peak and classifies the vertices with a surface descriptor value of greater than the inflection point as potential surface anomalies. It is noted the area under the curve of the PDF is the measure of probability; and, as such, the vertical axis values of the PDF are larger than one. Figures 4b and c show the color-coded point cloud of the planar and cylindrical datasets where vertices classified as likely damage (surface anomalies) are colored red. The SV for the points in the

damage patches is clearly identified as surface anomalies. However, many other undamaged vertices are also classified as surface damage. This makes sense given the PDF and the location of the inflection point. The computation and classification based on additional surface features, in combination with SV, was used to isolate the damage patches from the undamaged areas.

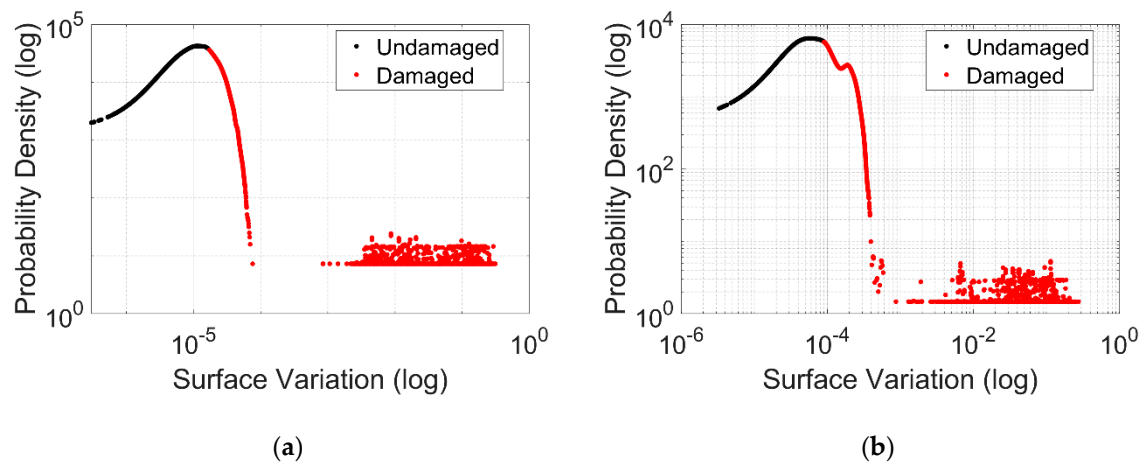
Figure 5. Surface variation kernel distribution analysis using log-log scaled PDF where the points colored black and red correspond to classified undamaged and damaged areas, respectively, for (a) planar and (b) cylindrical datasets.

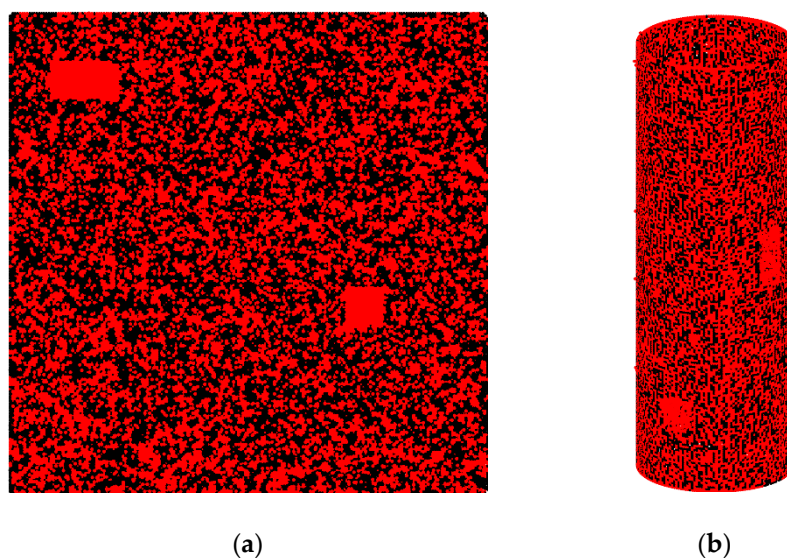
Figure 8. Likely damage by the normal vector-based damage detection method: (a) planar and (b) cylindrical datasets where detected surface anomalies are shown in red color (or gray color in black and white versions).

color-coded point cloud of both synthetic datasets based on NVG and NVL for the planar and cylindrical datasets, respectively, where surface anomalies and likely damaged vertices are colored red (gray). The patches of known surface damage are easily identified as consistent red (gray) regions for both components. However, similar to the classified results for SV, many points that are known to be undamaged were also classified as a potential surface anomaly based on the variation of the normal vector. This is due to both the presence of noise and uncertainty in the data points, as well as the sharp edges of the modeled components. It is reiterated that the combination of the classification results for all three surface features will be used for the final damage classification.

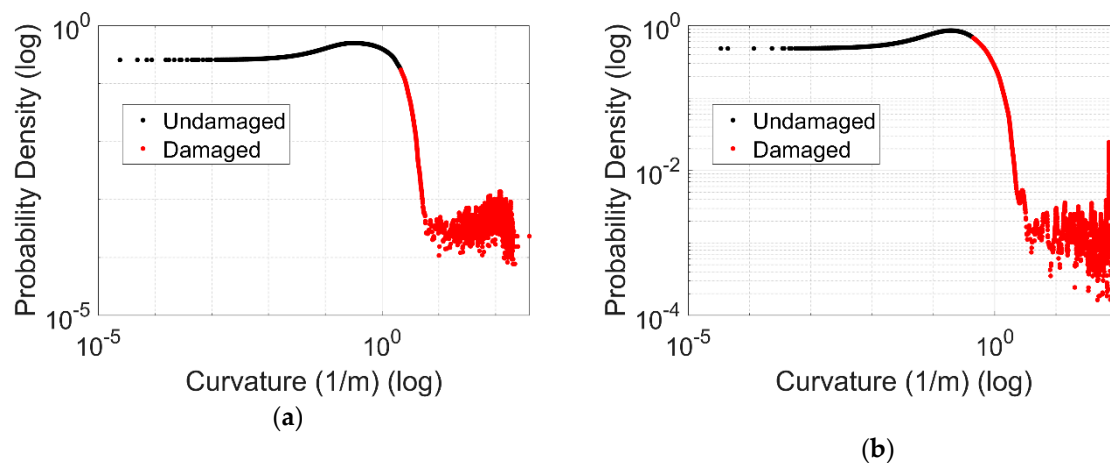
Figure 10. Curvature variation kernel distribution analysis using log-log scaled PDF where the points colored black and red correspond to classified undamaged and damaged areas, respectively, for (a) planar and (b) cylindrical datasets.

Similar to the previous surface descriptors, a kernel distribution was constructed for the mean curvature variation (CV) values and vertices were classified as potential surface anomalies based on the inflection point. Figure 10 depicts the log-log scaled kernel probability distribution of the mean curvature values along with the highlighted inflection point, which corresponds to a confidence level of 65.3% and 73.4% for planar and cylindrical datasets, respectively. Figures 9b and c represent the color-coded point cloud of the test specimen where surface anomalies and likely potential damaged vertices are colored red (gray). Similar to the previous surface descriptors, the damaged regions are easily identifiable; however, additional undamaged points are inherently included due to the use of the inflection point. The next section of this paper describes the damage evaluation step, which

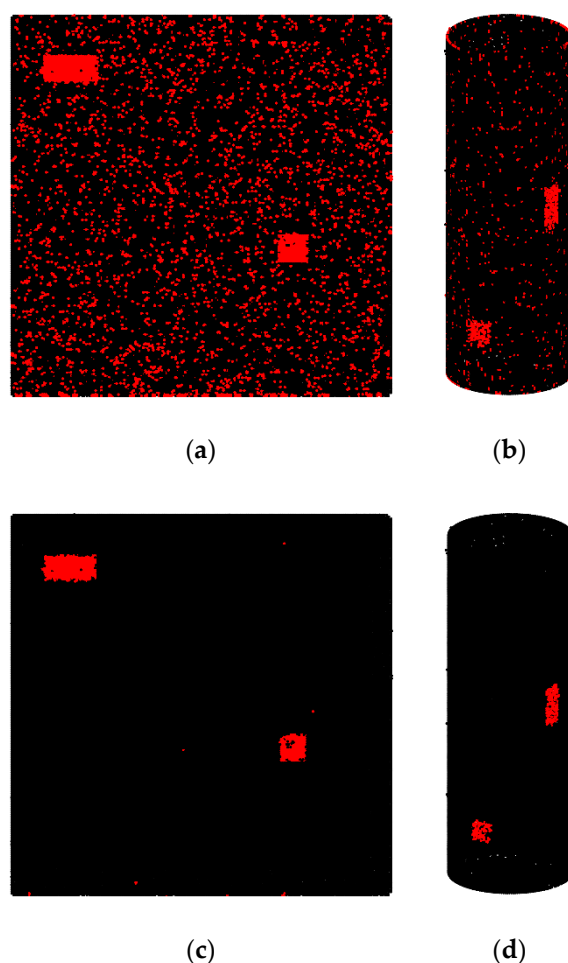
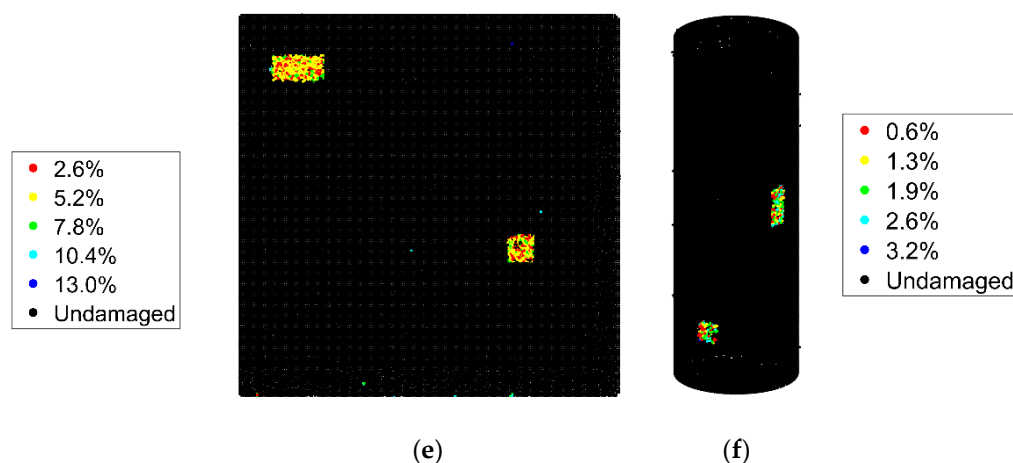
Figure 11. Results summary for the synthetic datasets: result of the damage evaluation step for (a) planar and (b) cylindrical datasets, result of the damage reevaluation step for (c) planar (d) and cylindrical datasets, and damage reevaluation classification based on five confidence intervals for (e) planar and (f) cylindrical datasets.

In the previous surface feature classification steps, a binary value of (1 or 0) was assigned to each vertex if they were classified as a surface anomaly (likely damage) or not, respectively. This binary value is referred to as the damage identifier (DI). Herein, zero or null denotes undamaged and unity indicates likely damage. In the evaluation step, the binary values were summed, and the vertex was classified as damage if the sum was equal to a value of 3, which indicates that it was classified as a surface anomaly by all three surface features. Figures 11a and b depict the results of the damage evaluation step for the planar and cylindrical datasets, respectively. While an improvement is clearly seen in comparison with the results of the individual surface feature descriptors, the damaged regions have not been entirely isolated. As shown in Tables 1 and 2 this corresponds to an increase in accuracy and precision for both datasets in the damage evaluation step. However, the FPR demonstrates that erroneous detection persists, with rates of 11% and 4% for the planar and cylindrical datasets, respectively. To refine the detection, each damaged vertex was reassessed one additional time to compare its evaluated DI with that of its k neighboring vertices. This is referred to as the reevaluation step in Tables 1 and 2. In this final step, each vertex DI was updated to reflect damaged if and only if more than 3/4 of its eight closest neighboring vertices (i.e., six vertices) were classified as damage. This step further eliminates sparse erroneous vertices within the classified point cloud. Figures 11c and d illustrate the result of damage evaluation and reevaluation for the planar and cylindrical

datasets, where approximately 4.0% and 1.0%, respectively, of the entire point clouds were ultimately classified as likely damage. The precision and recall values after the damage reevaluation step were computed for the planar dataset as 98% and 67%, respectively, while the FPR values were reduced to less than 1% from an original value of 11% (Table 1). As for the cylindrical dataset, the precision and recall values were computed as 99% and 63%, respectively, while the FPR values were reduced to less than 1% from an original value of 4% (Table 2).

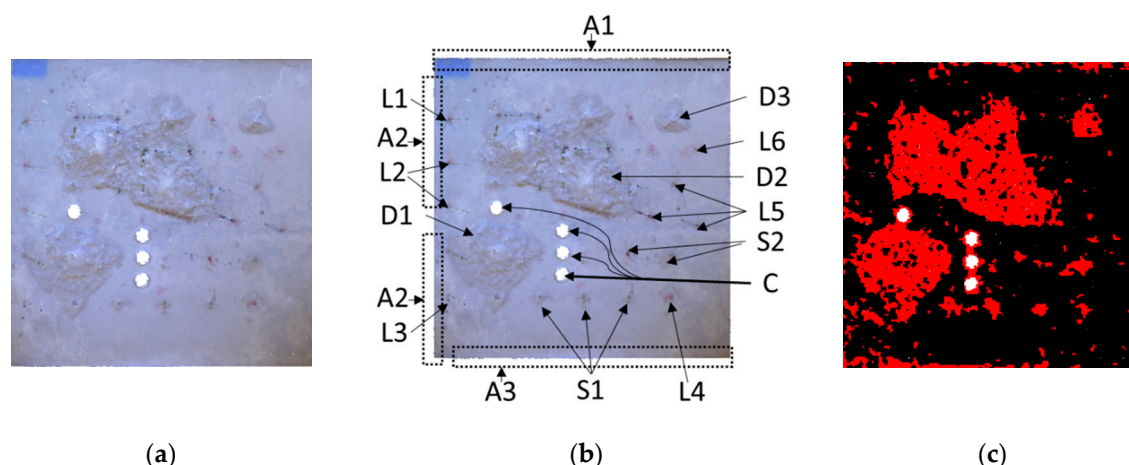
Figure 12. The example concrete specimen: (a) RGB-colored point cloud, (b) summary of damaged regions, and (c) color-coded point cloud where red-colored vertices represent likely damaged areas.

The first case study is a lidar point cloud of a concrete bridge deck specimen that was tested in the laboratory. The point cloud dataset represents the top surface of the deck only and can be considered a planar surface. Figure 12 depicts the concrete specimen, which had nominal dimensions of 2.10 m (L), 2.10 m (W), and 0.16 m (D). The point cloud was collected using three scans at a close range (distance from the scanner to the target less than 2 m), and a resultant cloud of 900,000 vertices was achieved with a vertex density of roughly 20 vertex/cm³ and mean alignment error of 0.8 mm. The selected slab was primarily used for a shallow-embedded post-installed anchor test program, which resulted in various damage patterns and surface anomalies due to testing and construction [40]. As demonstrated in Figure 12b, damage includes shallow surface defects with depths of 1 to 3 cm as illustrated by regions S1 and S2, three extensive regions of spalling with a maximum depth of 7 cm denoted by D1, D2, and D3, four circular core extractions with a diameter of 15 cm denoted by C, the remains from rebar that failed in tension denoted by L1 to L6, and edge nonuniformities due to construction as shown by regions A1, A2, and A3.

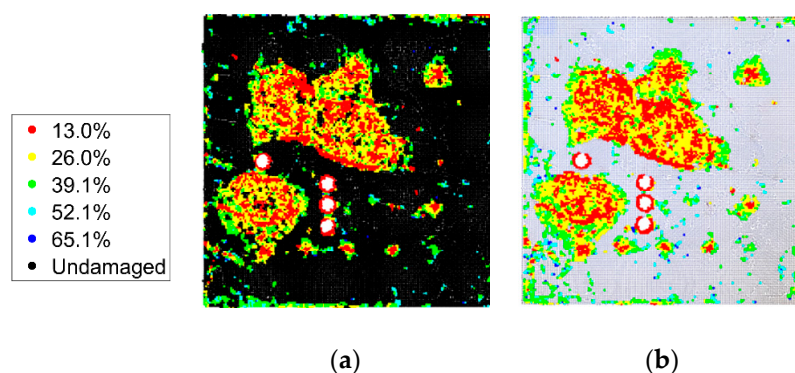
Figure 13. The confidence interval analysis result for the concrete specimen: (a) damaged reevaluation classification based on five confidence intervals and (b) the superimposed classification detected damaged on the original point cloud.

The selected point cloud dataset was initially regularized with a grid step of 1 cm to uniform the vertex-to-vertex spacing, and the noise removal process eliminates the sparse vertices using k and α of 31 and 3, respectively. Afterward, the SV, NVG, and CV damage detection methods evaluated the point cloud using the neighboring number of 8, 8, and 2, respectively. Figure 12c visualizes the final result following damage reevaluation for the concrete specimen where the potential damage is shown by the color red (gray in black and white versions), and the undamaged areas are shown by the black color. The damage reevaluation step used similar parameters to those used in the synthetic datasets. Figure 13a shows the results of the damage reevaluation step after classification of the damaged vertices into n bins corresponding to different confidence levels, where n is a user-defined parameter ($n = 5$ for this case). Figure 13b depicts the various confidence intervals of detected damage superimposed on the colored point cloud data. As can be seen, the proposed damage detection method accurately detects the various surface defects and further classifies the detected damaged based on the damaged area's severity. Since the point cloud vertex-to-vertex spacing was regularized with a grid step of 1 cm, the method was able to identify surface anomalies as small as 2 cm. As illustrated in Figure 13, the severely damaged areas correspond to the first confidence interval (shown by the red color) while less severe surface nonuniformities correspond to the second and third confidence interval (shown by yellow and green colors). Lastly, the minor surface anomalies are included in the fourth and fifth confidence intervals that correspond to vertices with a light and dark blue color. The detected damage was verified using linear measurements to assess the accuracy of the method using three significant regions of spalling, D1–D3, where the summary values are provided in Table 3. The maximum discrepancies are on the centimeter level with a maximum discrepancy of 4%, for the largest linear dimension.

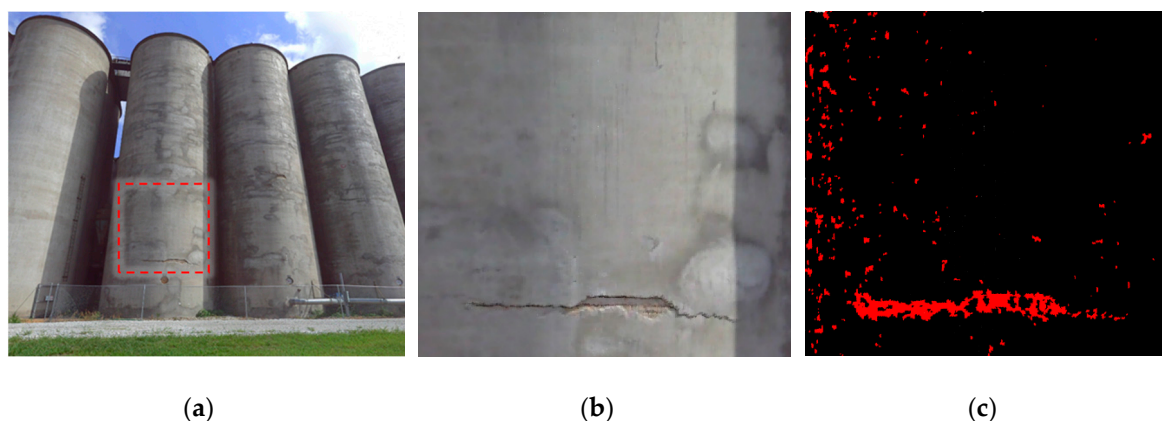
Figure 14. Grain silo structure case study: (a) image of the silo and (b) RGB-colored point cloud of selected ROI, and (c) color-coded point cloud where red-colored vertices represent likely damaged areas.

To demonstrate the robustness of the developed method to detect damage for nonplanar surfaces, an exterior wall of a concrete grain silo was selected for analysis. Silos are cylindrical structures and their exterior wall carries a considerable magnitude of horizontal pressure, vertical gravitational force, and frictional shear force (depending on the stored material), especially at lower heights [41]. In addition, Dogangun et al. denoted that the failure of such structures can have devastating consequences; therefore, it is critical to inspect such structures routinely for defects, cracks, and global deformations [41]. The silo structure selected for this study is approximately 30 m tall with a diameter of 12 m with a noticeable horizontal crack and concrete spalling near its base (Figure 14a). To scan the selected silo structure, a total of four lidar scans at a distance of 20 m were performed and resulted in a point cloud with an aligned mean accuracy of 2.8 mm. The final point cloud has a vertex density of 2 vertex/cm³. To test the method for large scale real-world example, a 6 m by 6 m section of the silo's point cloud was segmented out. The selected region of interest (ROI) is shown using a red box in Figure 14a. The selected region for the case study had a total of 43,000 vertices and sustained a moderate cracking and severe loss of cover as shown in Figure 14b.

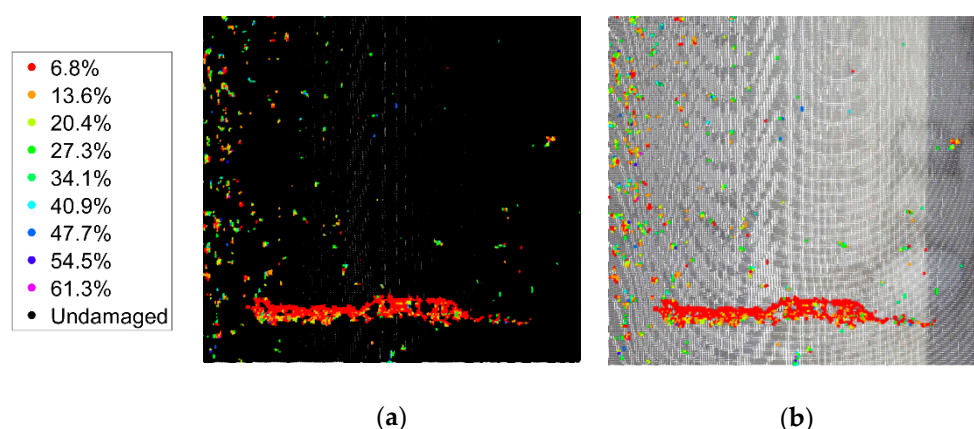
Figure 15. The confidence interval analysis result for the ROI of the nonplanar case study structure: (a) damaged reevaluation classification based on nine confidence intervals and (b) the superimposed classification detected damaged on the original point cloud.

As the selected point cloud dataset had a vertex density of 2 vertex/cm³, the point cloud was regularized with a grid step of 1 cm to uniform the vertex-to-vertex spacing, and the noise removal process eliminated the sparse vertices using a k and α of 31 and 3, respectively. As the structure represents nonplanar geometry, the SV, NVL, and CV damage detection methods were used to evaluate the point cloud based on identical parameters to those used for the second (cylindrical) synthetic dataset. Figure 14c visualizes the final result of the damage reevaluation step for the concrete specimen, where the potential damage is shown by the color red (gray in black and white versions) and the undamaged areas are shown by black. Note that the damage reevaluation step also used identical parameters to that used for both synthetic datasets. Figure 15a shows the results of the

damage reevaluation step after the classification of the damaged vertices into nine confidence level bins. Figure 15b depicts the various confidence intervals of the detected damage superimposed on the colored point cloud data. As illustrated in Figure 14c, the developed method was able to successfully classify the majority of the vertices within the ROI that corresponds to cracking and spalling as damaged vertices. However, due to the nature of the structure's construction and exposure to the environment, various surface anomalies exist throughout its height. While the majority of these anomalies fall outside of the first confidence interval, additional significant anomalies are classified within the first confidence interval and are shown by red in Figure 15. This demonstrates the ability of the proposed damage detection method to detect the surface defects and further classify the detected damage based on the damaged area's severity. Since the selected ROI point cloud vertex-to-vertex spacing was regularized with a grid step of 1 cm, the method was able to identify surface anomalies as small as 2 cm. While the proposed method could be implemented for larger areas of the silo, the voxelization of the point cloud would have to be conducted at a much wider vertex-to-vertex spacing due to the use of GBL on the very tall structure. Therefore, the use of a larger area would reduce the algorithm's sensitivity to detect smaller areas of damage. In a similar approach for the concrete slab, the linear dimension of the observed and detected damage verification was done for the horizontal dimension, resulting in a percent difference of 4%.

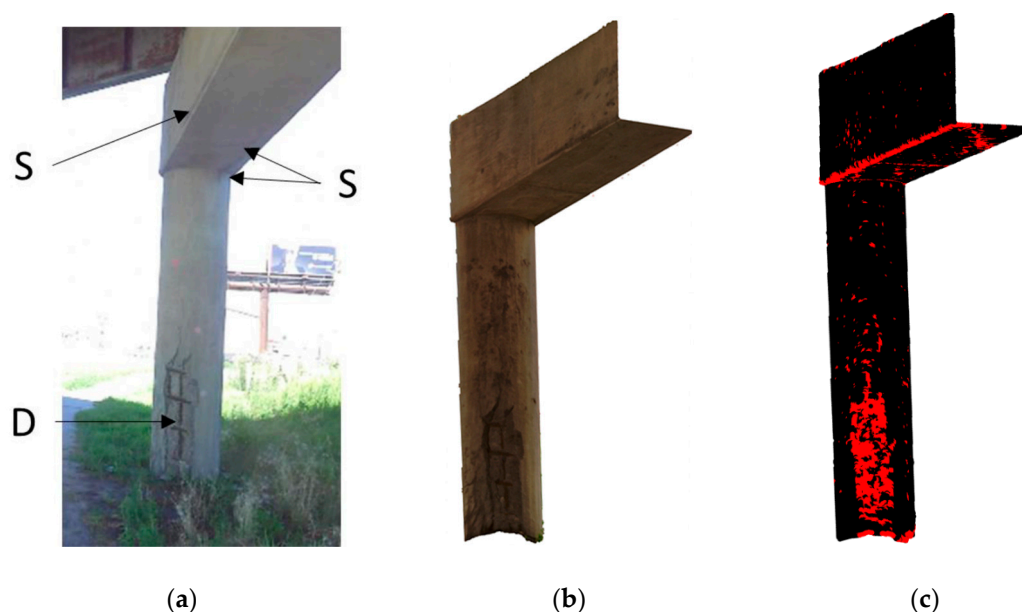
Figure 16. The complex geometry case study: (a) the image of bridge pier along with observed defects, (b) RGB-colored point cloud, and (c) the color-coded point cloud data where color red (grey color in black and white versions) represents the detected potentially damaged areas.

The third case study is a bridge column that supports a transverse horizontal beam. As shown in Figure 16, the selected ROI is a complex geometry containing cylindrical and multiplanar surfaces. The primary damaged area includes extensive concrete spalling at the base of the pier (denoted by D in Figure 16a). Other surface anomalies on the transverse beam include the influence of a chamfer and uneven edges due to the construction formwork located at the beam-column connection and the bottom edge of the beam (denoted by S in Figure 16). The column has a diameter of approximately 0.80 m and a height of 3.2 m, and the transverse beam had a depth and width of approximately 0.90 and 0.78 m, respectively. The corresponding point cloud of the ROI consists of 320,000 vertices collected by a single lidar scan at a standoff distance of approximately 10 m, which resulted in an average vertex density of 3 vertex/cm³.

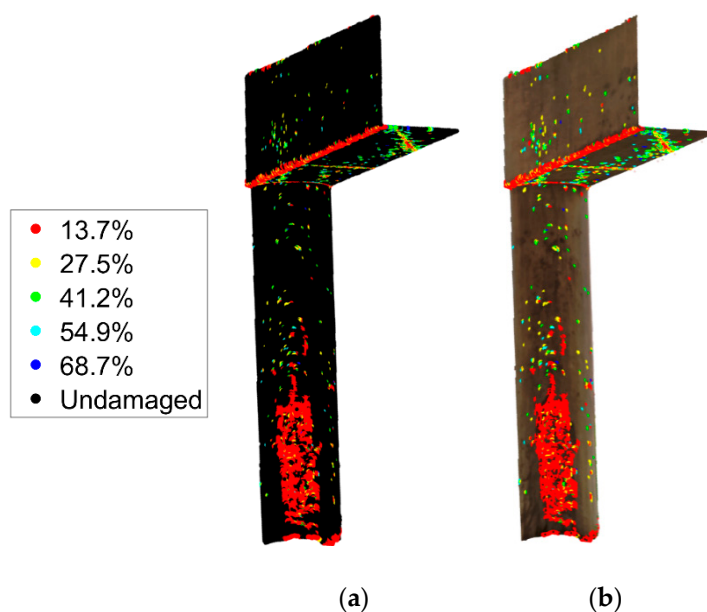
Figure 17. The confidence interval analysis result for the complex geometry case study: (a) damaged reevaluation classification based on five confidence intervals and (b) the superimposed classification detected damaged on the original point cloud.

As the dataset contains various surfaces with a variety of geometries, the developed method uses the SV, NVL, and CV damage detection methods to analyze the case study point cloud. The developed algorithm initially minimizes vertex-to-vertex spacing through the regularization process with a grid step of 1 cm, and eliminates erroneous vertices using identical parameters selected for two previous real-world case studies. Afterward, neighboring numbers similar to that used for the second synthetic dataset were selected to analyze the point cloud. Figure 16c depicts the final result of the damage reevaluation step for the selected ROI, where the potential damage is shown by the color red (gray in black and white versions) and the undamaged areas are shown by black color. As shown in Figure 16c, while the detection algorithm was able to detect significant concrete spalling at the base of the column, the algorithm classifies most of the surface nonuniformities and sharp features (i.e., edges) as potentially damaged areas. Figure 17a shows the results of the damage reevaluation step, which classified damaged vertices into five bins corresponding to different confidence levels. Figure 17b depicts the various confidence intervals of detected damage superimposed on the colored point cloud data. As shown in Figure 17, the vertices corresponding to the significant spalling at the base of the column were classified within the first confidence interval (less than 13.7% and shown by the red color) and the majority of minor surface anomalies, including uneven edges due to the construction formwork located at the beam–column connection and the bottom edge of the beam, were classified between the second and fifth confidence intervals. To validate the damage, the vertical linear dimension was compared to the measured field value. It was found that the error is approximately 2.5% where the detected height is 122 cm compared to a measured value of 119 cm, which equates to the average voxelization of the point cloud.

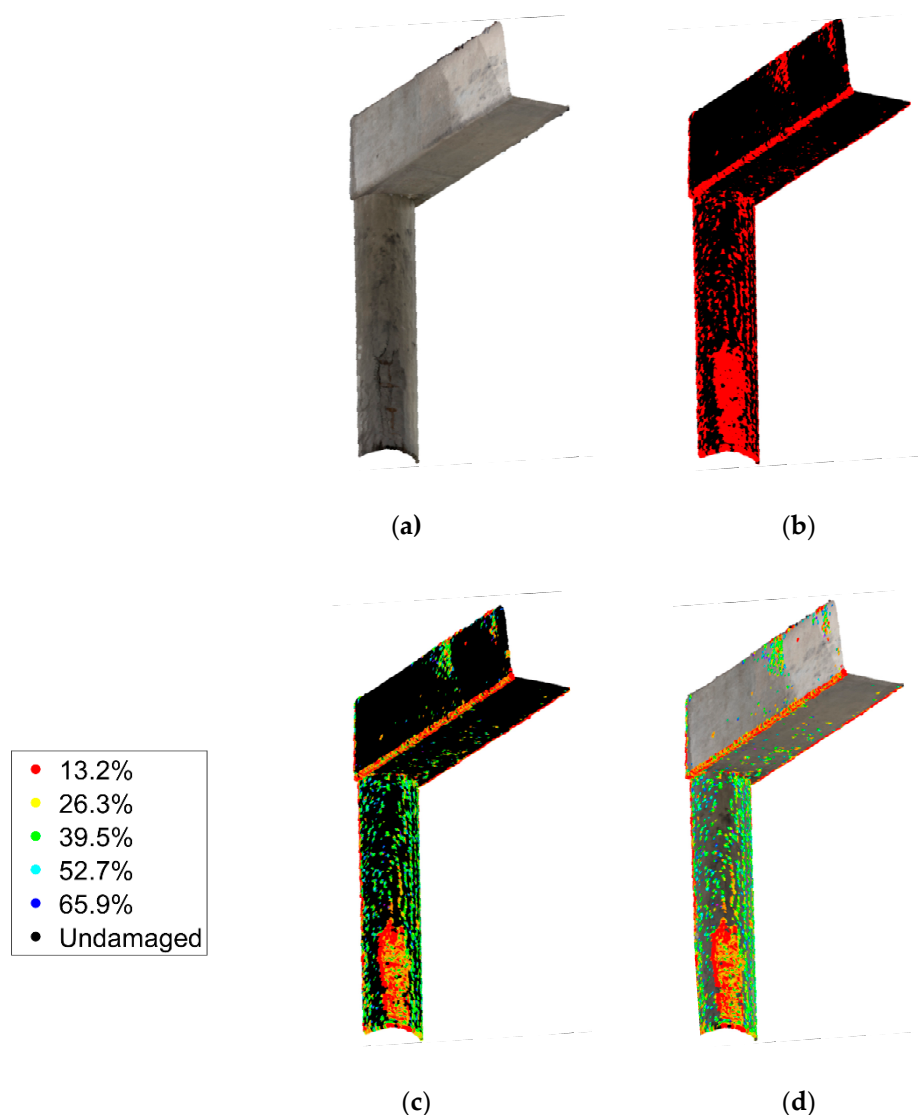
Figure 18. The SfM point cloud analysis results for the of the bridge bent cap: (a) RGB-colored SfM point cloud (b) the color-coded point cloud data were color red (grey color in black and white versions) represents the detected potentially damaged areas, (c) damaged reevaluation classification based on five confidence intervals, and (d) the superimposed classification detected damaged on the original SfM point cloud.

The SfM-derived point cloud of the bridge bent cap was analyzed using similar input parameters and damage detection methods as the lidar dataset. Figure 18b shows the final result of the damage reevaluation step, where the potential damage is shown by the color red (gray in black and white versions) and the undamaged areas in black. As shown in Figure 18c and similar to the detection results for the corresponding lidar dataset, the detection algorithm was able to detect the significant concrete spalling at the base of the column. However, the algorithm classifies most of the surface nonuniformities and sharp features (i.e., edges) as potentially damaged areas. Figure 18c presents these results according to the five bins of the confidence level. Figure 18d depicts the various confidence intervals of detected damage superimposed on the colored point cloud data. In general, the SfM results are similar to that of the lidar results in both identification and quantification. In comparing the vertical dimensions of the detected damage to the field-measured value, a difference of 6.7% is noted at the centimeter level. This discrepancy may be due to estimating a lineal scale factor as well as local distortion and noise within the SfM point cloud, which is known to vary within SfM point clouds (e.g., [42,43]).
